CON-AID in Uganda

Introduction

Kaserem-Sipi-Kapchorwa Road:

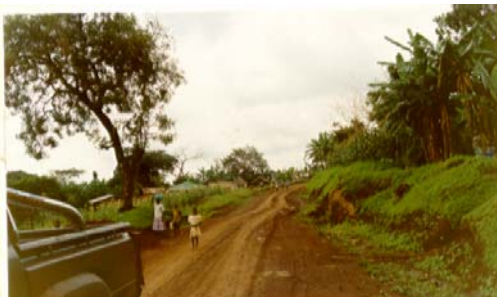
Before CON-AID Application on Kaserem-Kapchorwa Road (beginning of escapment before Sipi Trading Center)
 Five years after CON-AID application Kaserem-Kapchorwa road (beginning of escapment before Sipi Trading Centre)
