Stabilization of Military Airstrip in Afghanistan

November 2005

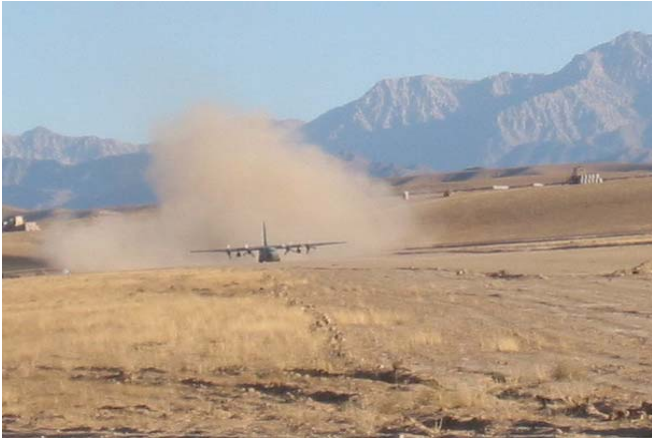
Hercules C130 taking off in a dust cloud

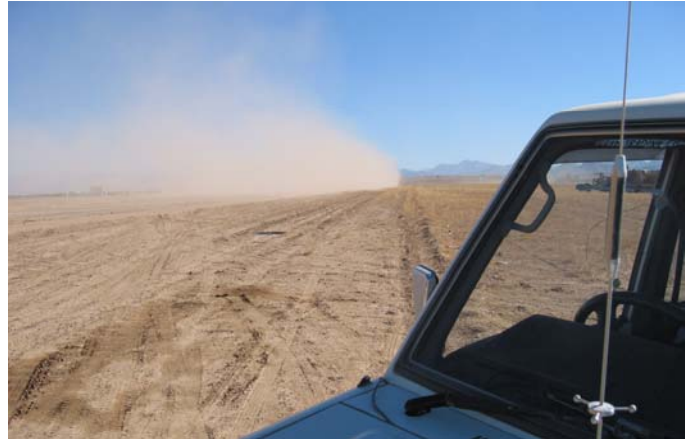
A C130 Hercules has just landed

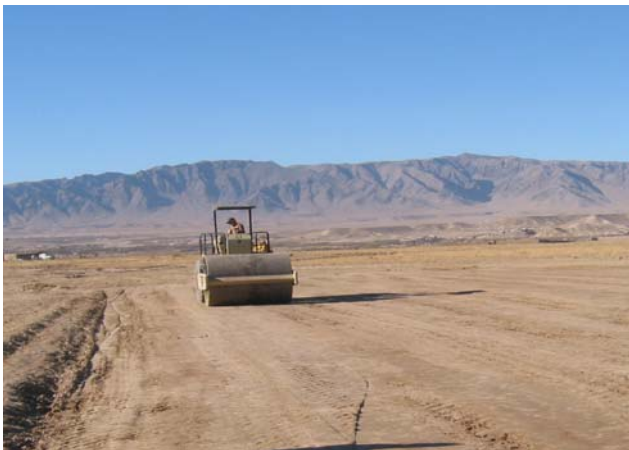
Compacting the treated runway

Shortly after completion rains set in for three days non-stop, with the runway hardening and being solid enough for the planes to continue using the airstrip. The runway was then also compacted with a vibrating roller compactor, to leave hard dry surface.

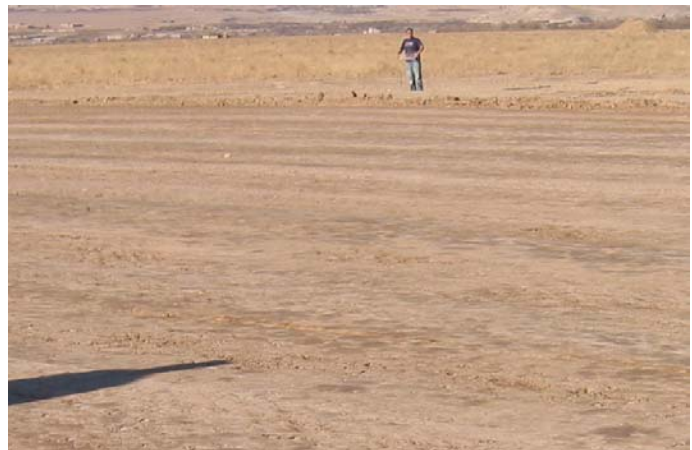
Compacted runway

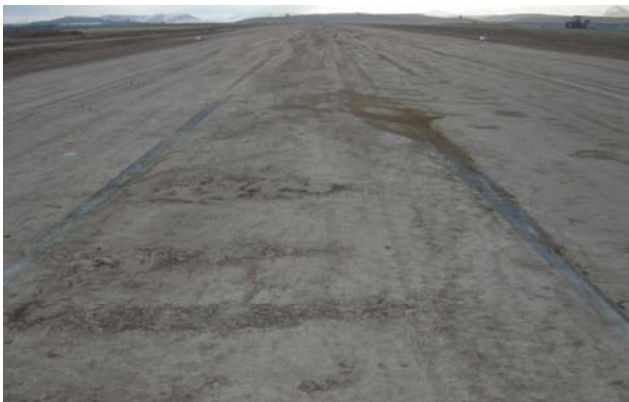
Tire marks on the runway where planes touch down

The runway surface has stabilized now to such an extent, that the C130 planes leave rubber tire marks on the runway surface where the aircraft wheels touch down and make contact with the runway.

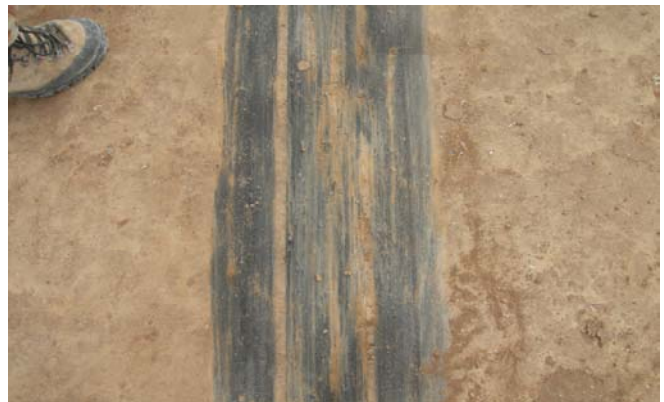
Close up view of tire marks.
