Stabilisation of a ramp at Johannesburg athletics stadium

(IMIESA: Volume xix No. 6 June 1994)

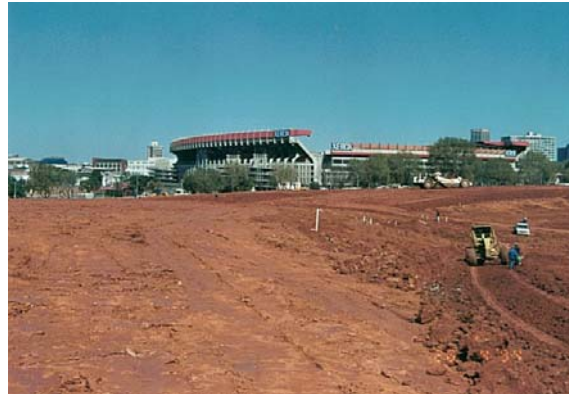
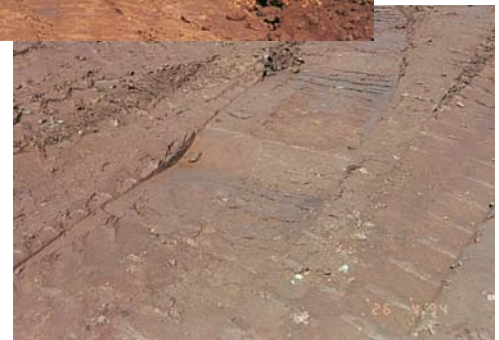
Because so much water was trapped in the soil, the CON-AID chemical was applied at the low rate of 1:10. Although the usual minimum application rate is 1:200, CON-AID's engineers believed that the application of the chemical would release the trapped absorbed water from the clay. This released absorbed water would thus assist with the diffusion of the CON-AID within the material and achieve a virtual "chain reaction". The CON-AID was applied by hand using watering cans, after which a grader was used to blade-mix the material. The ramp was then left undisturbed for the next five days.

Upon resumption of work after the election holidays, the layer was re-mixed by the grader blade and compacted using a tamping roller. As this layer was not thick enough to support the heavy loads transported by the scrapers, it was decided to introduce a further 150 mm layer of the same material for treatment with CON-AID. As this material had much lower moisture content, the entire operation of mixing and compacting could be completed in a day.
